Dummy Wafer in June

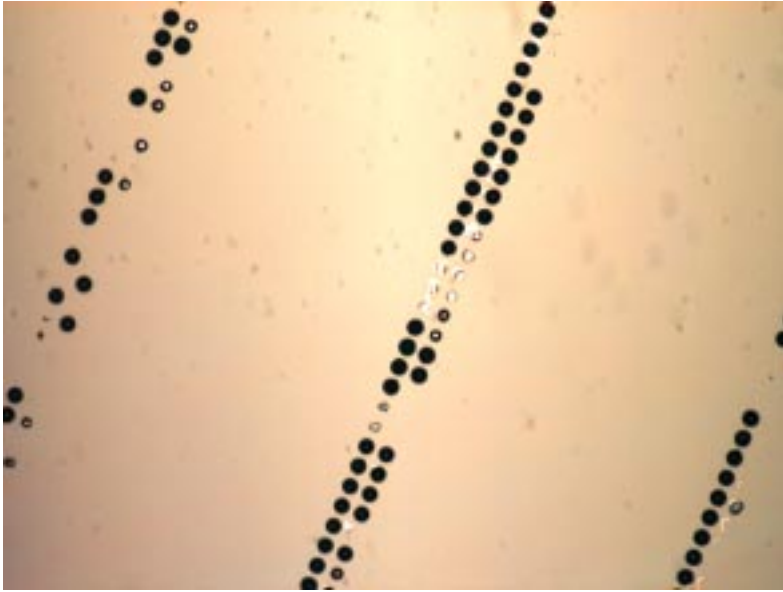
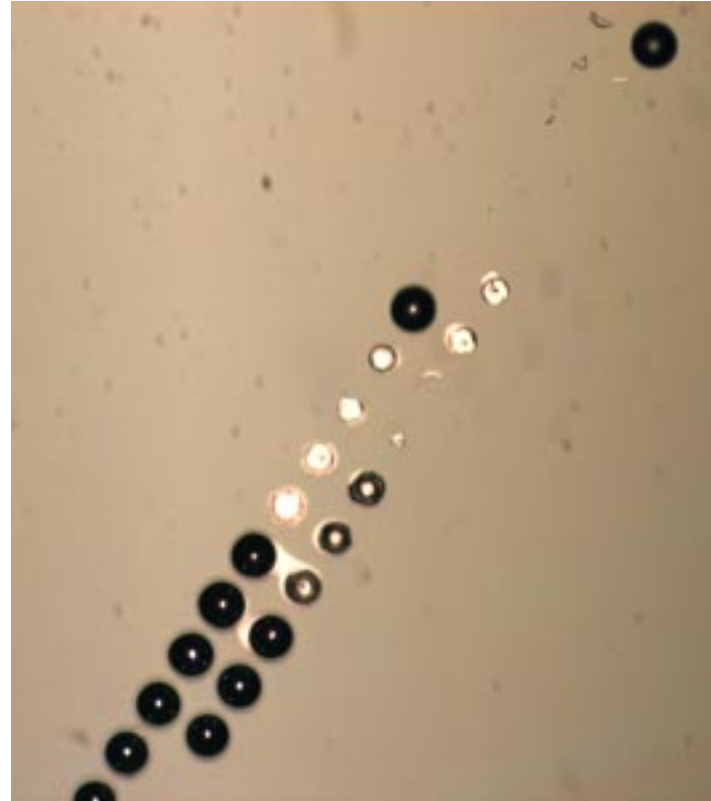
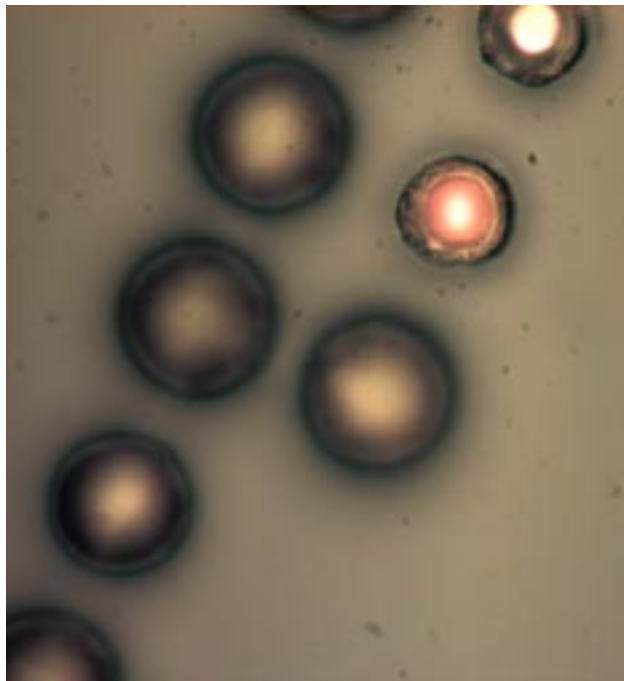
Wafer cracked during grinding is claimed. Also broke piece during handling
Bumps removed - see pictures
No evidence of significant residual photoresist when washed one piece.
Tentative conclusion is that UV releasing tape grabbed photoresist and pulled most of it all along with some bumps and under bump metal
